**Subject: Request to Borrow Earthen Material, Summit Canyon, San Juan County, Utah**

**Summit Canyon Borrow Area**  
August 3, 1998

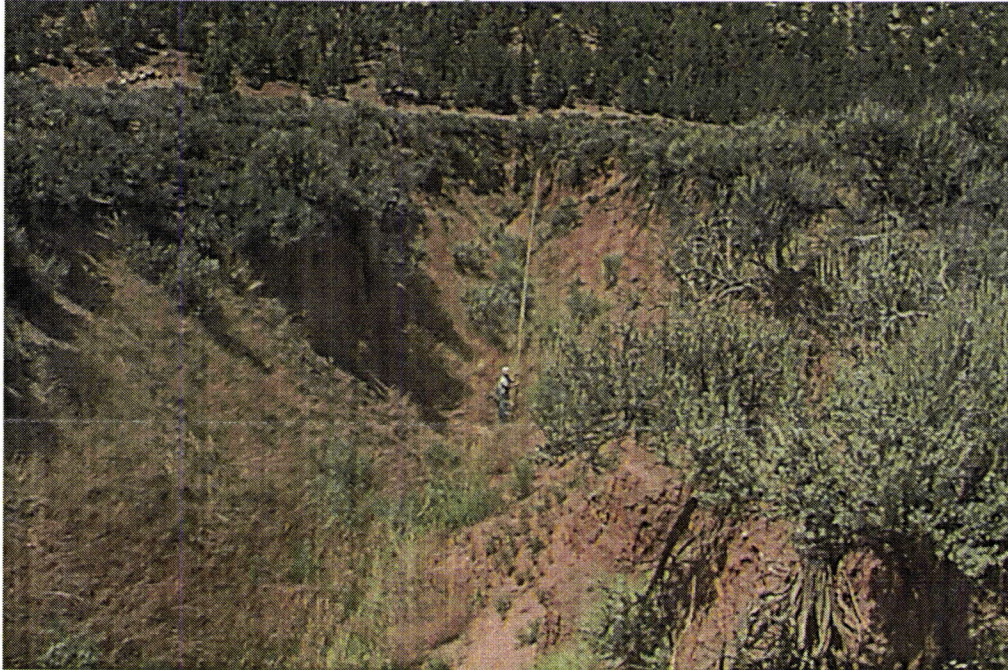
Looking northwest, with the west side of the borrow area on the right, and east side of the secondary borrow area on the left. The staff shown is 25 ft. in length.

Enclosed is a map showing the location of the proposed borrow area, and a secondary borrow area that could be utilized if necessary. The borrow area is approximately 3.7 acres and the earthen material in the area is at least 25 feet deep, as shown in the attached photographs. Umetco plans to borrow approximately 40,000 cubic yards of material. The average depth of excavation will be approximately 7 feet with depth ranging from 12 to 13 feet on the west side to 2 to 3 feet on the east side.

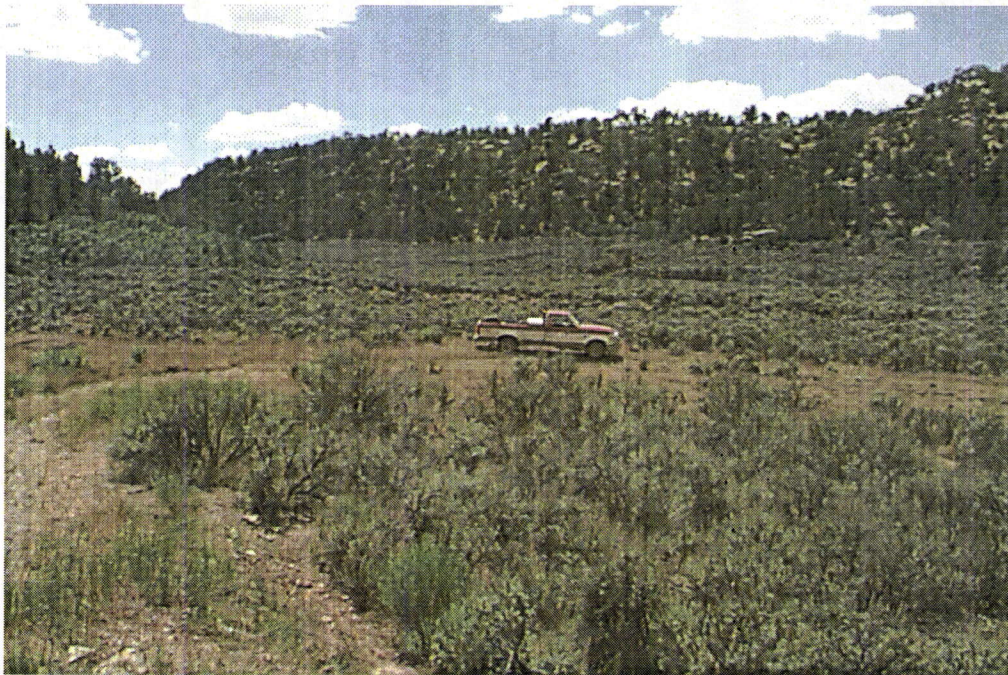
Looking southwest, at the main bend in the access road within the south central portion of the borrow area. In the background is the secondary borrow area.
